Manhole Inspection Summary

Manhole # S39S__042MH

Insp Date: **3/13/08 8:57 AM**

Location Address: **1417 anchor st**

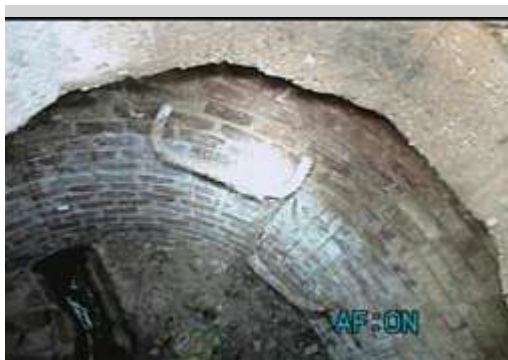
Defect 2

Count: **2** Missing: **0** ☒ **Corroded**

corroded steps

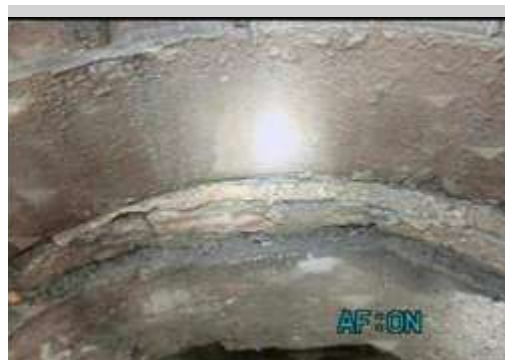
Defect 1

Offset: **2** (in.)

Condition: ☐ Sound ☒ **Cracked** ☐ Root Intrusion ☐ Loose Brick ☐ Deteriorated

chimney cracked frame offset

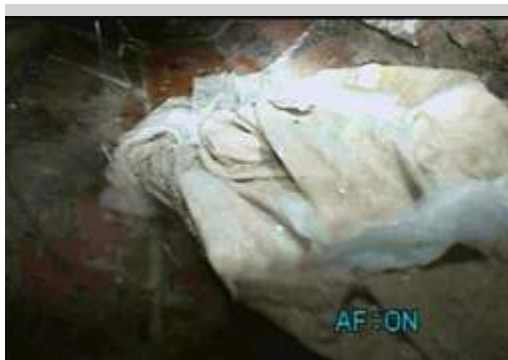
Defect 4

Condition: ☐ Sound ☐ Cracked ☐ Root Intrusion ☐ Deteriorated ☐ Leaks ☒ **Debris**

channel debris

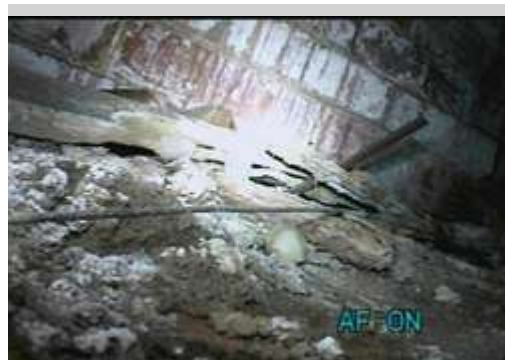
Defect 3

Condition: ☐ Sound ☐ Cracked ☐ Root Intrusion ☐ Deteriorated ☐ Leaks ☒ **Debris**

bench debris

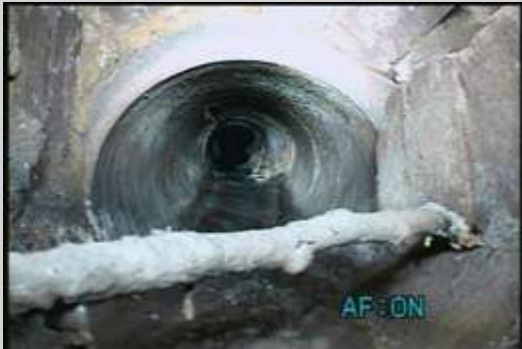
12 O'Clock Outflow

8 in. Circular Gravity Sewer
Pipe Out @ 12 O'Clock

Invert Depth: **6.80** (ft.) Flow Characteristics: **Fast**

Deposits: ☒ None ☐ Mud ☐ Sludge ☐ Debris ☐ Grease

Infiltration: **None** Pipe Seal Cond: **Unknown**

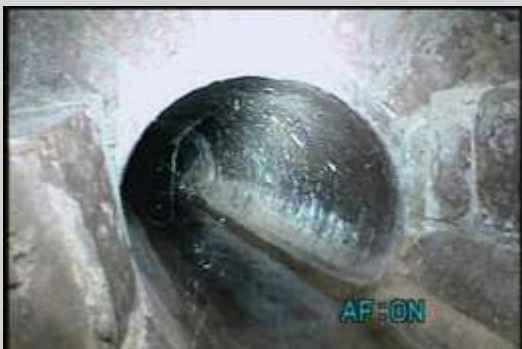
3 O'Clock Inflow

8 in. Circular Gravity Sewer
Pipe In @ 3 O'Clock

Invert Depth: **6.60** (ft.) Flow Characteristics: **Fast**

Deposits: ☒ None ☐ Mud ☐ Sludge ☐ Debris ☐ Grease

Infiltration: **None** Pipe Seal Cond: **Unknown**

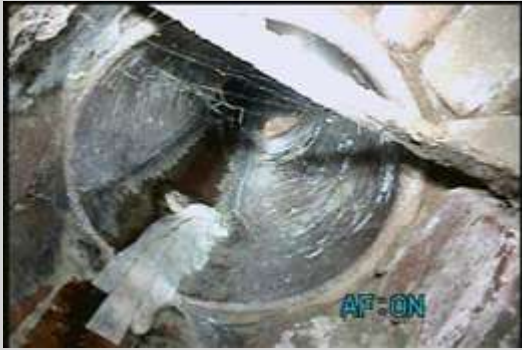
9 O'Clock Inflow

8 in. Circular Gravity Sewer
Pipe In @ 9 O'Clock

Invert Depth: **6.40** (ft.) Flow Characteristics: **Slow**

Deposits: ☒ None ☐ Mud ☐ Sludge ☐ Debris ☐ Grease

Infiltration: **None** Pipe Seal Cond: **Unknown**
